# Lake Tarpon Sail and Tennis Club

## *Milestone Inspection*

RT23-0011

RE: Phase 1 – Milestone Inspection  
Lake Tarpon Sail and Tennis Club

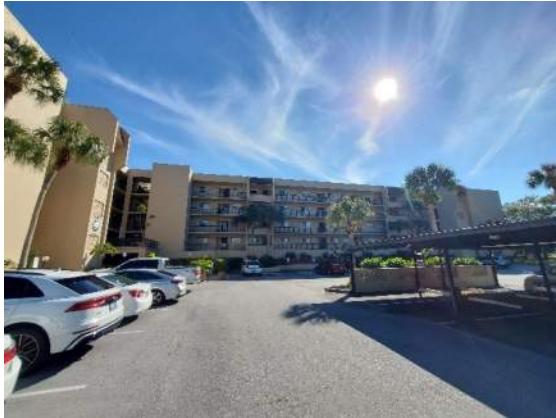
**Picture 1:** Typical Front Elevation

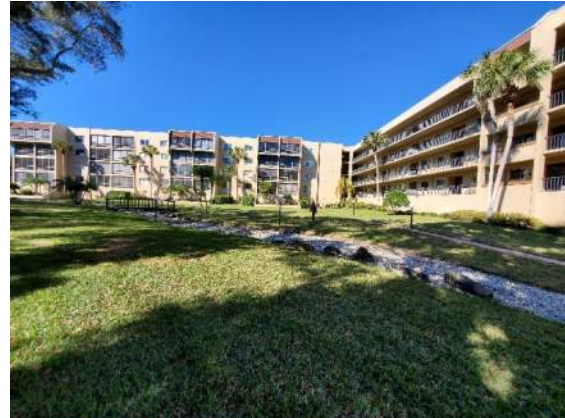
**Picture 2:** Typical back Elevation

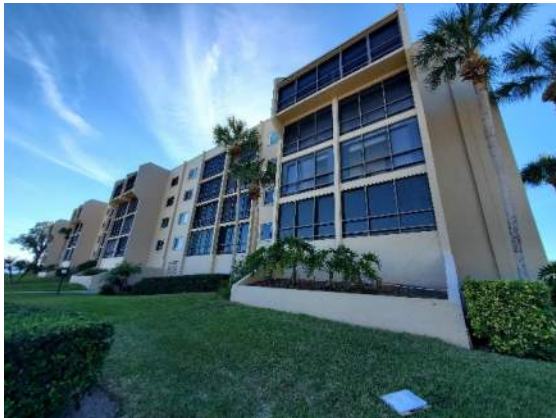
**Picture 3:** Typical left Elevation

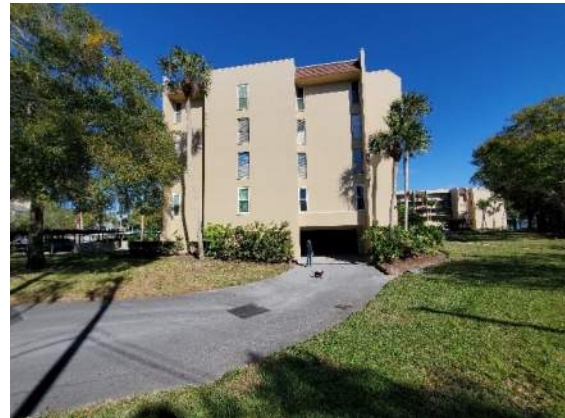
**Picture 4:** Typical right Elevation
